# CONDENSER 9241414

## KENWORTH/PETERBILT CONDENSER PRODUCT NOTE

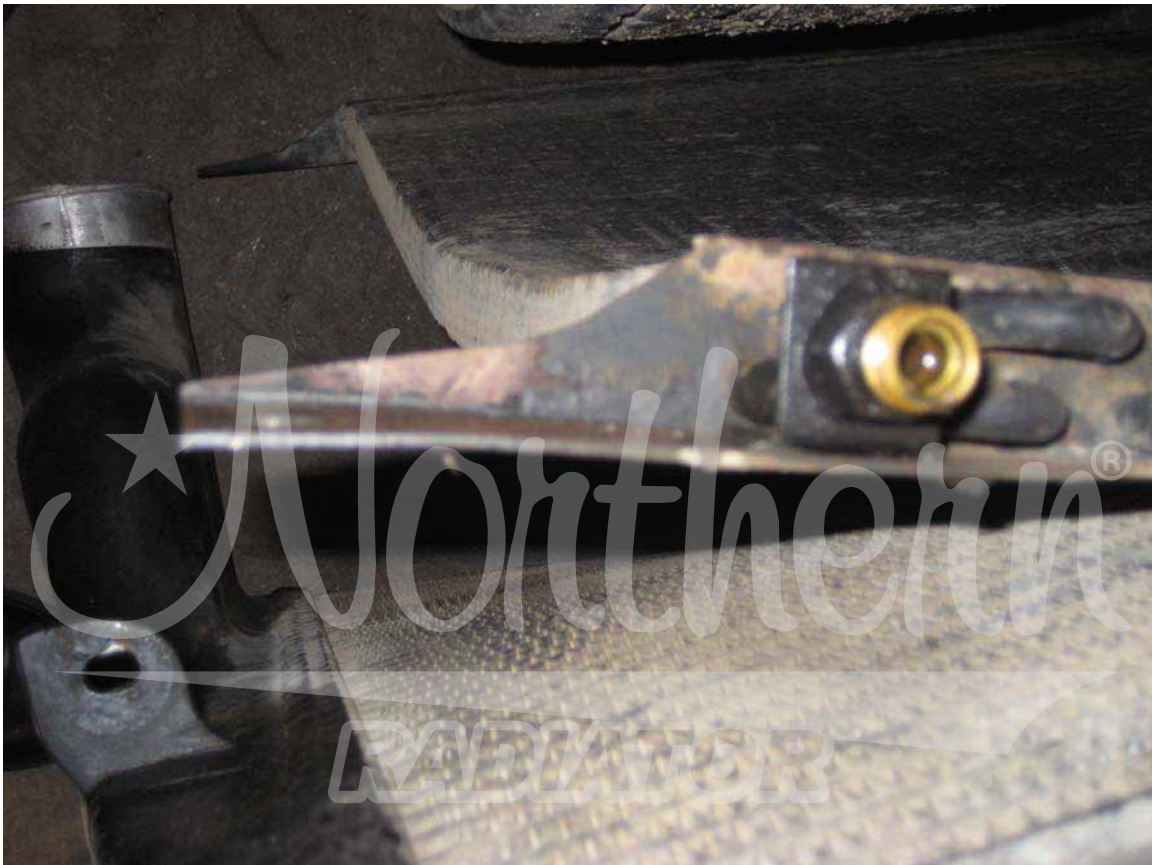
Check the condenser bottom bracket as compared to the unit removed from the truck. If the removed unit looks like the unit shown in the below photo, proceed to check the truck for hood brace clearance with the hood closed and the old unit bolted in position. If required cut and notch the replacement bracket accordingly.
